LARGE RECTANGULAR VACUUM WINDOWS*

James E. Walter Lawrence Berkeley Laboratory, University of California Berkeley, California 94720

Summary

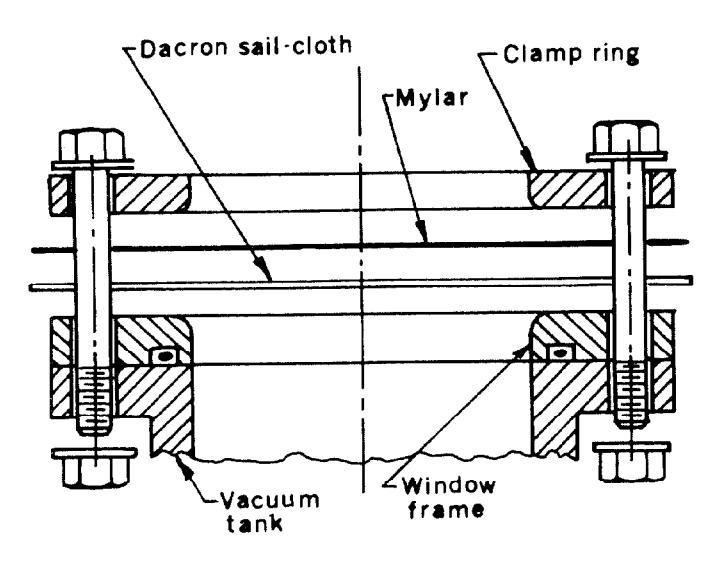
Fig. 2. Window assembly.

The dacron cloth and mylar are epoxied ** onto a window frame which is placed between a clamp ring and the vacuum tank. The epoxy fills the weave of the cloth and provides the vacuum seal between the mylar and the window frame. The seal between the window frame and the vacuum tank is made with a conventional O-ring (Fig. 2). Before assembly both the mylar and the window frame are fine sandblasted in the area where epoxy will be applied to provide a good bonding surface. The dacron cloth is then sandwiched between the mylar and the frame and a small clamp bar is placed at the edge of the window. This prevents any epoxy from running over the radius which could cause an edge failure. Next epoxy is applied between the cloth and frame and between the cloth and mylar. After squeezing out all air bubbles, the assembly is clamped and allowed to dry over night (Figs. 3 and 4).

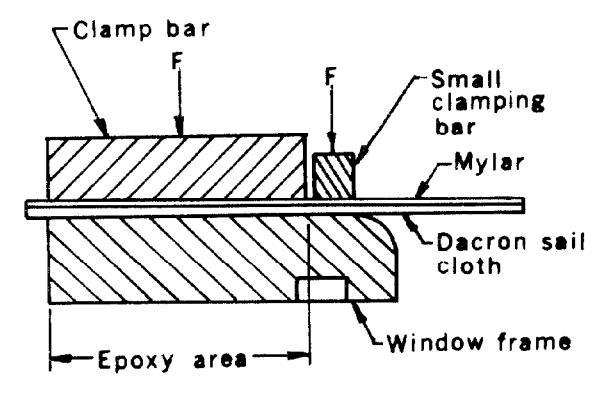
Fig. 3. Epoxy procedure.

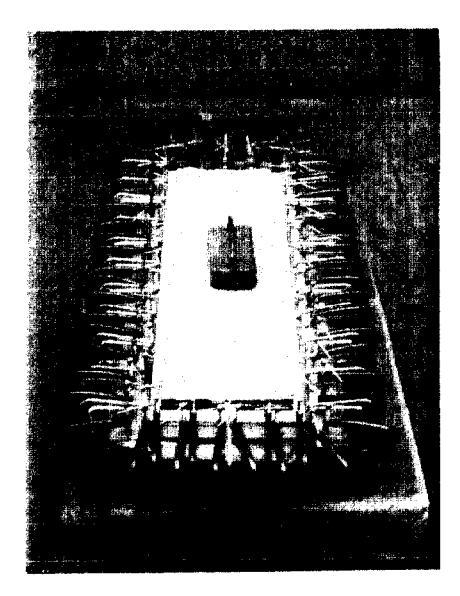
Fig. 4. Clamping procedure.

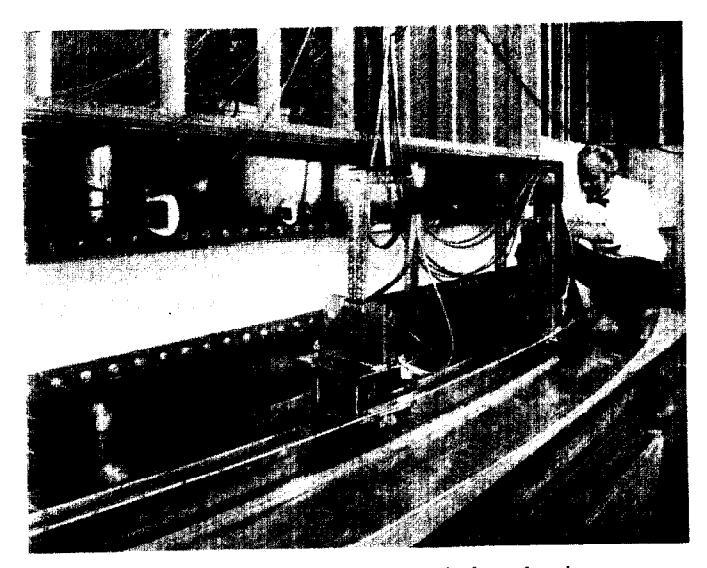
Fig. 6. 12 x 144 in. vacuum window for heavy ion experiment. Dr. H. Heckman shown adjusting equipment.

Another window presently in use is 12×144 in. with 13 oz dacron cloth and 5 mil mylar. A heavier cloth was used for added safety because the experimenter has to work within inches of the window (Fig. 6). Presently being fabricated is a window of 6.5 oz dacron cloth with 5 mil mylar on a 10 x 30 in. frame.

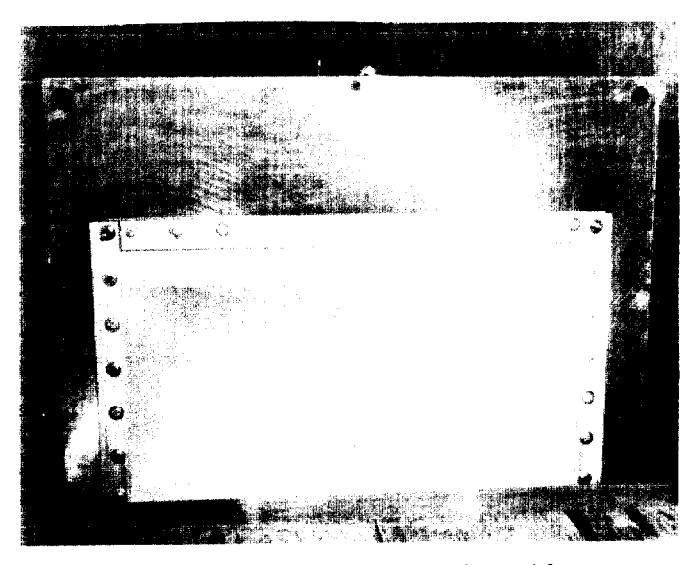
Fig. 7. $18 \ge 40$ in. vacuum window with square corners. Note small puncture hole lower edge.

To determine what would happen when punctured, the $18 \ge 40$ in. window of 9 oz dacron and 5 mil mylar was installed on a large vacuum tank inside a concrete blockhouse. The tank was evacuated and a 1/4-in. diam rod with a chisel point was pushed through the window. The result was just a 1/4-in. diam hole in the window which slowly let the tank up to air (Fig. 7). It did not rip or fail catastrophically as would be expected from a plain mylar window.
