## Exchange and Repair of Titanium Service Pipes for the EXFEL Series Cavities

Marco Schalwat, Serena Barbanotti, Alexej Daniel, Heiko Hintz, Kay Jensch, Axel Matheisen, Steven Saegebarth, Patrick Schilling (DESY, Hamburg), Andreas Schmidt (XFEL.EU, Hamburg) Deutsches Elektronen-Synchrotron, DESY, Notkestrasse 85, 22607 Hamburg, Germany.

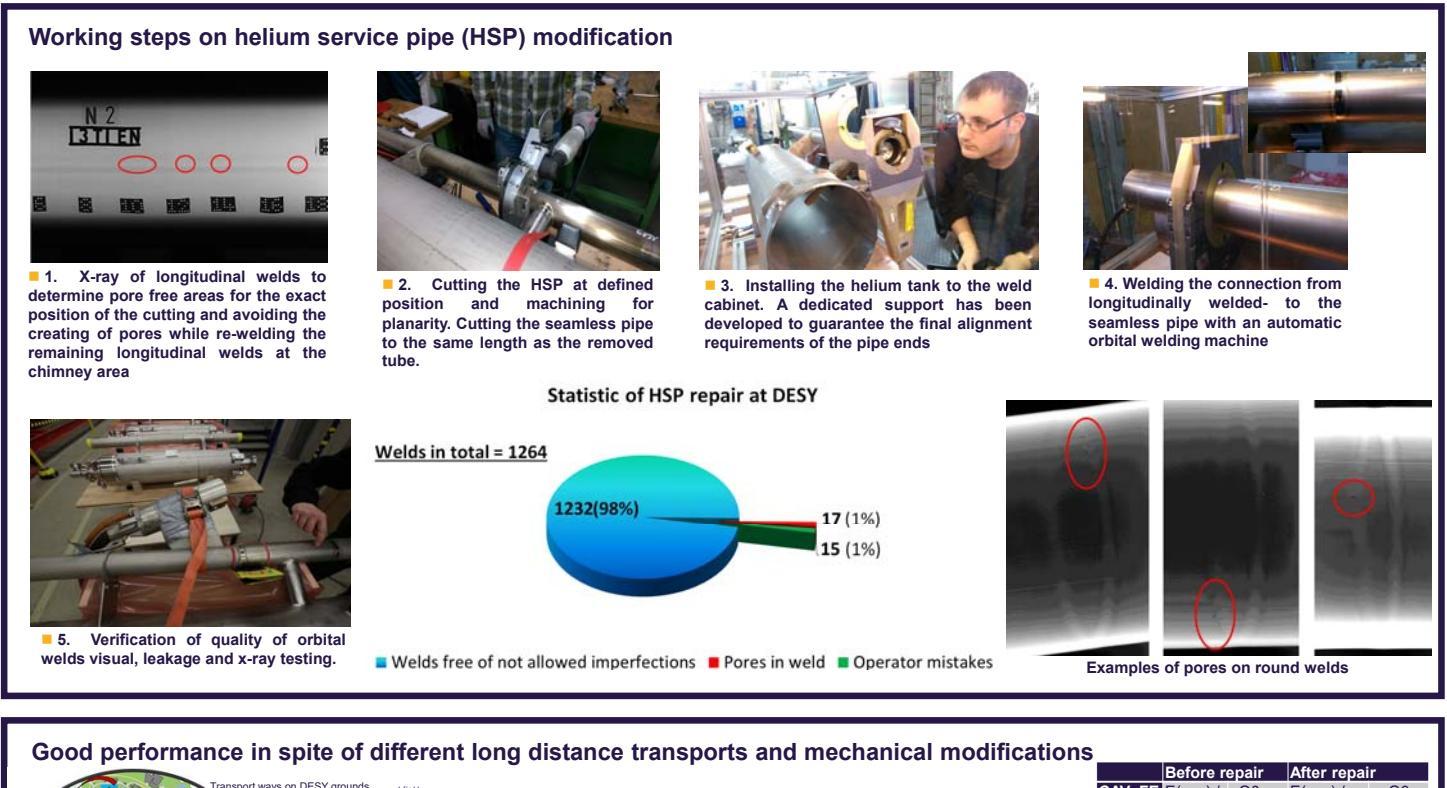
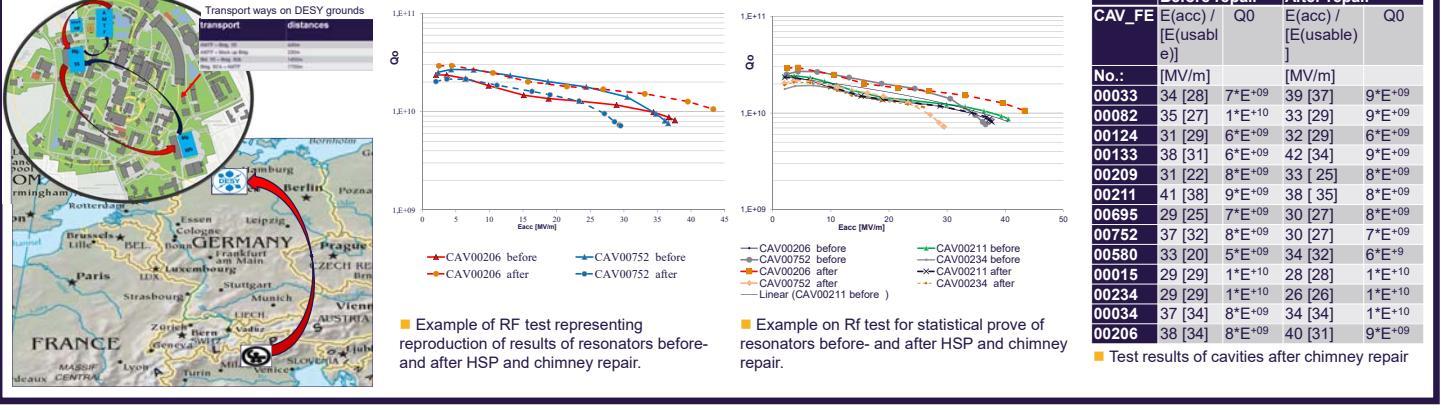
## Additional repair in the "chimney area"

about 70 tanks also showed non acceptable pores located in the so called "chimney area"
Repair procedure:

1. X-ray re-examination of chimney area

- 2. Marking of pores area on tube
- . Grinding of the affected tube to remove

Manual welding with filler

- 5. Visual testing and leak check of weld area
- 6. X- ray examination for verification of manual weld and removal of pores
