## STATUS OF THE SNS SUPERCONDUCTING CAVITY TESTING AND CRYOMODULE PRODUCTION\*

J. Mammosser [1], TJNAF, Newport News, VA. 23606, USA

Thomas Jefferson Nation Accelerator Facility (Jefferson Lab) in Newport News Virginia, USA, is fabricating superconducting accelerator modules for the Spallation Neutron Source (SNS) project, currently under construction in Oak Ridge, Tennessee. This paper outlines the production requirements and gives an update on the current status of the production of these modules. The paper also discusses the problems encountered in production to-date, vertical and horizontal RF test results on cavities and the status of the electropolish program at Jefferson Lab.

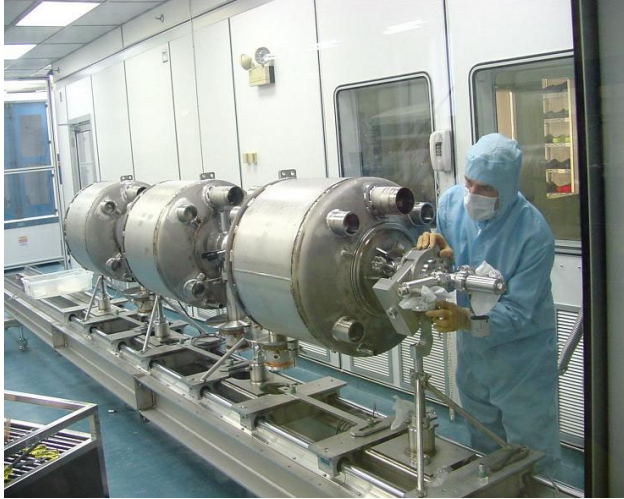
Figure 1: Typical assembly of a MB string.

Before strings can be assembled, received cavities must be processed, assembled and qualify in a vertical test. So far, twenty one cavities have been RF qualified in vertical tests and assembled into strings and turned over for completion into cryomodules M1-M7. A typical MB string assembly in the production cleanroom is shown in Figure 1.

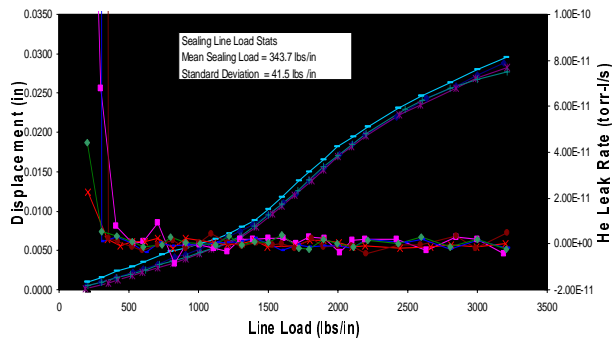
Figure 4: Seal Loading Data.

Figure 4 shows that the seals are leak tight under ideal conditions with line loading of less than 500 lbs/in. and seal crushes of only a few thousandths of an inch. The reason the cavity seals were leaking in production, was that for the calculated line load the actual loads were much lower on the real hardware because much of the force was going into friction (galling) due to clean hardware with no lubrication for sliding. Along with this standard vacuum bolt hardware was used which only marginally allowed for the needed load. In other words the bolts were at their limits for yielding under load values chosen to work at non-ideal flange surface-conditions or seal crushes of fifteen thousandths of an inch.

These issues were resolved by providing better alignment of components during assembly, removal of scratches by mechanical polishing and providing a higher and more consistent line loading of the seals. All seals are now at a torque of 40 ft lbs and use high strength bolt (A286) hardware. The following Figure 4 shows data from seal loading tests made with a special apparatus. The test system consisted of a press with a load cell that would

provide loading two ideal mock flanges. A seal was placed between the two flanges and a load was applied and the flange spacing was measured optically to determine the displacement or seal crush for the load applied. This work was performed by Larry Phillips and Tim Rothgeb.
