IMPEDANCE OF THE FLANGE JOINTS WITH THE RF CONTACT SPRING IN NSLS-II*

A. Blednykh[†], B. Bacha, G. Bassi, C. Hetzel, B. Kosciuk, V. Smaluk, T. Shaftan, G. Wang
 BNL, NSLS-II, Upton, NY, USA

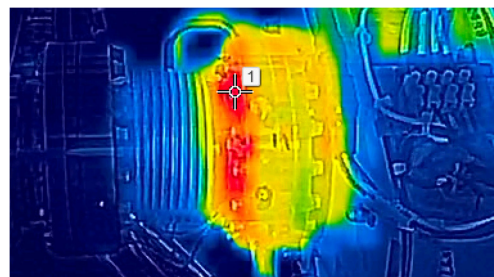
Figure 2: Thermal image of the attached bellows to the flange of the vacuum chamber made by the FLIR AX8 infrared camera, where the local overheating appeared.

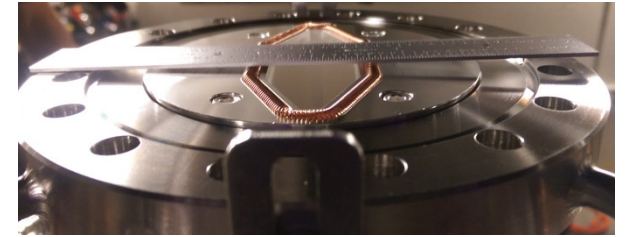
Figure 4: Flange image of the bellows with trapezoidal groove and the RF contact spring at place after disassembling.

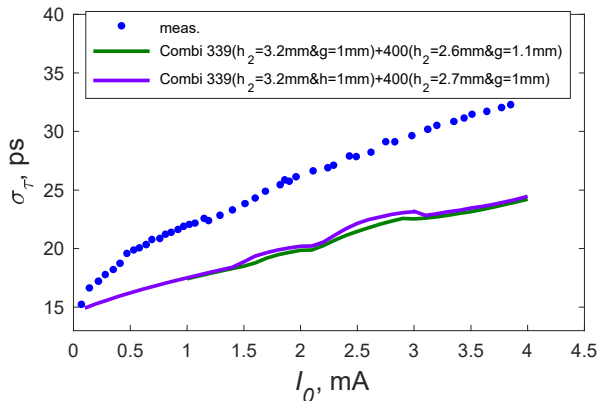
Figure 7: Bunch length dependence on the single bunch current. The experimental data are shown with blue points. The purple and green traces are the numerically simulated results.

Despite the good agreement shown in Fig. 6 between measurements and simulations of σ_δ a discrepancy has been observed in the comparison of the bunch length (σ_τ), as shown in Fig. 7 at $V_{RF} = 3MV$. The blue dots correspond to the streak camera measurements for the regular 3DW

lattice and the purple solid trace corresponds to the numerically simulated results by the SPACE code. We are presently investigating the reason why we can reproduce well the energy spread behaviour while, the bunch lengthening slopes differ by a factor of 1.4. The low-frequency part of the longitudinal impedance, especially the imaginary part needs to be further investigated and analysed in detail to resolve and understand the difference between the results. We believe that with a streak camera resolution better than $0.5ps$ we will be able to detect changes in bunch length, where the beam becomes unstable, especially at high enough RF voltage.
