# FLASHOVER ON RF WINDOW OF HWR SRF CAVITY

## Abstract

The Chinese initiative Accelerator Driven Sub-critical System (CiADS) project is based on a 10 mA, 1.5 GeV CW proton linear accelerator for nuclear waste transmutation. The main components of the Linac are superconducting radio frequency accelerating cavities. CiADS project needs a high stability linac to demonstrate the technology of 10 mA CW beam of superconducting front-end linac for ADS technology.

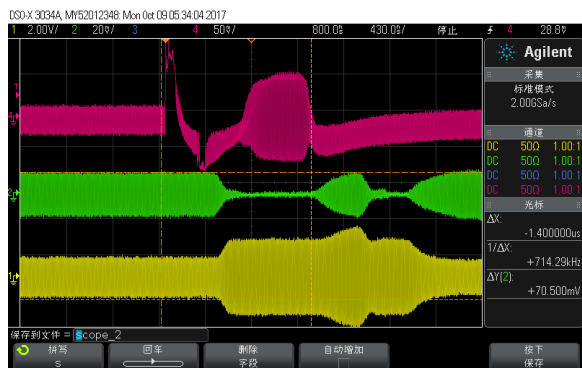
Figure 1: The signal with pickup-drop on oscilloscope.

The pink signal is pick up power (Pt) from cavity, the green one is forward RF power (Pf) and the yellow

one is reflected RF power (Pr). The frequently deviant signal result to the irregular responses of LLRF control system and limit the stable operation of the SRF linac. The pick-up signal shows that there is discharge happened on the surface of RF ceramic window [1].

The first cryomodule of this linac includes six 162.5 MHz HWR010 cavities working at 4K with optimum beta equal to 0.1. In one of coupling ports of the cavity, a power transmission antenna rooted in a RF ceramic window to pick up the RF field power. We measured the pickup-drop signal of HWR010 PT and showed in Fig. 1.

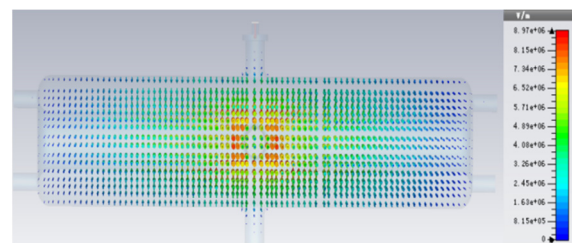
Figure 2: The electric field in HWR010 SRF cavities.

The electric field is strongest in the middle of the cavity and is weakest at the ends. The magnetic field is weakest in the middle and strongest at the ends. FE particles were attached to the cavity surface with the high electric field area

This simulation was performed in CST Microwave Studio. The simulation results of electromagnetic field of the cavity is showed in Fig. 2 and Fig. 3.

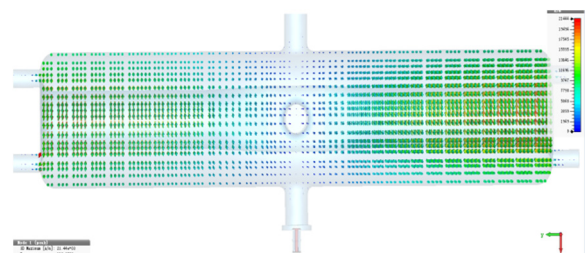
Figure 3: The magnetic field in HWR010 SRF cavities.

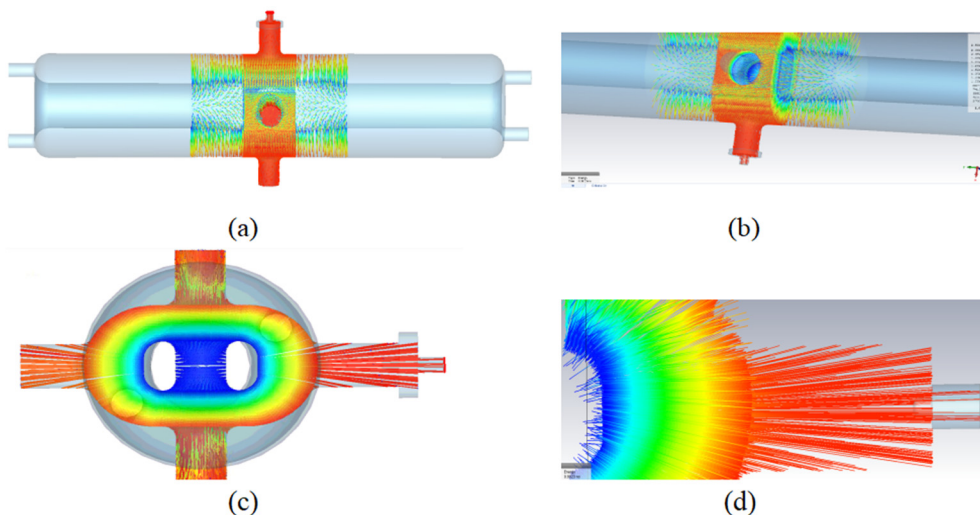
The particles movement in electromagnetic field shows in Fig. 4. The particles movements straight along the electric field line for the movements were dominated by the electric field, and the weak magnetic field has little effect on their direction of motions. These particles will finally hit on the PT antenna and ceramic window, as shown in Fig. 4 (d). The energy of the bombarding electrons is too strong to producing secondary electrons on the surface of ceramic. Therefore the flashover occurs by field emission electrons constantly accumulated on the surface of ceramic window.

Figure 4: The FE particles trajectory simulation of HWR.

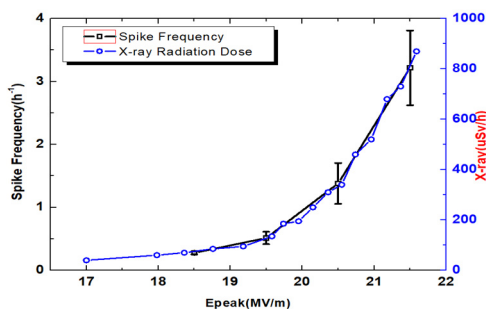
In order to further understand the physics between the phenomena, the frequency of pick-up-drop signal at different  $E_{pk}$  were monitored. The interval of each pickup-drop decreases as the increase in accelerating gradient. Figure 5 also displays the radiation dose caused by bremsstrahlung effect increases exponentially with the accelerating gradient, which indicates that the field emission effect inside the cavity is much stronger at high accelerating gradient, and it agrees with the F-N theory [2]. Therefore, the frequency of pickup-drop is proportional to field emission. The accumulated field emission electrons on the window may be the reason of flashover.

Figure 5: The frequency of pickup-drop and radiation dose are proportional to gradient.

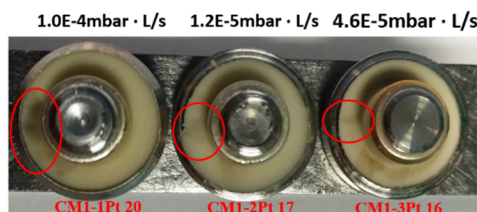
The surface of ceramic windows in PT couplers of the first three HWR010 SRF cavities (CM1-1,CM1-2,CM1-3) in module 1 have been presented completely (Fig. 6). The left one with some dark area. There are three obvious and clear discharge channels on the surface of the middle one. A more obvious and wider discharge channel on the surface of the right one. The trace on the surface of the window proved that there is flashover happened.

Figure 6: The surface of ceramic windows.

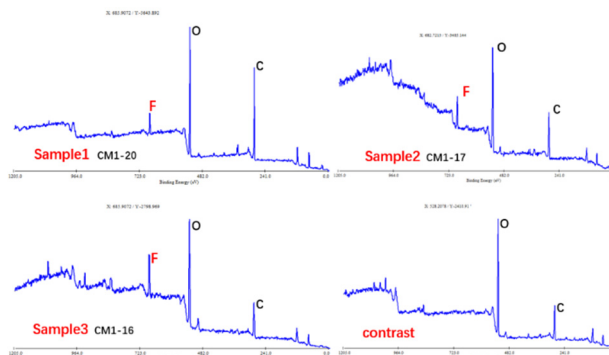
Figure 7: The results of elemental component test by XPS.

The windows as samples are placed on the X-ray photo electron spectroscopy (XPS) measurement platform for inspection (Fig. 7). The elemental component of the surface of the window can be performed. The ceramic window in PT coupler taken from the SRF cavity without the occurrence of field emission was tested as the contrastive sample. The samples with flashover trace has fluorine on the surface and without fluorine on the contrastive one. The fluorine comes from HF on the surface of the SRF cavity and was transported by field emission electrons [3].

The field emission should be the original reason of flash-over.

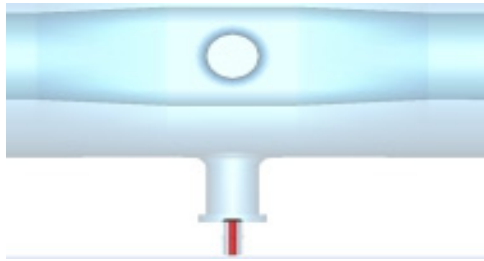
Figure 8: A modified design of electrically coupled antenna.

In light of above analyses, in order to solve the problem, it is essential to avoid the FE electron impact the ceramic window of pick-up coupler. Two types of pick-up coupler were designed with the  $Q_e$  of about 5E11. One is an electrical coupler, whose antenna was designed with a cap on its top to absorb the FE electrons and guide them away through cable, at the same time the cap of the antenna covers the ceramic window at the bottom to avoid the impact of FE electrons (Fig. 8).

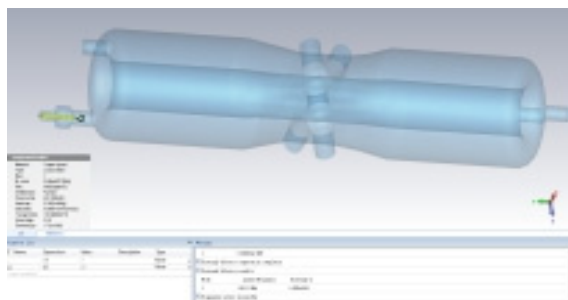
Figure 9: A modified design of magnetic coupled antenna.

The other type of the pick-up coupler will be set at the end of the cavity with strong magnetic field and weak electric field. The electric field in this region is too weak to support FE effect act. As the magnetic field is strong in this region, the pickup antenna is designed a magnetic coupled loop made by niobium (Fig. 9).
